Manhole Inspection Summary

Manhole # S59C__002MH

Insp Date: **1/9/09 9:32 AM**

Location Address: **1 KRESSON-I 895-ALLEY**

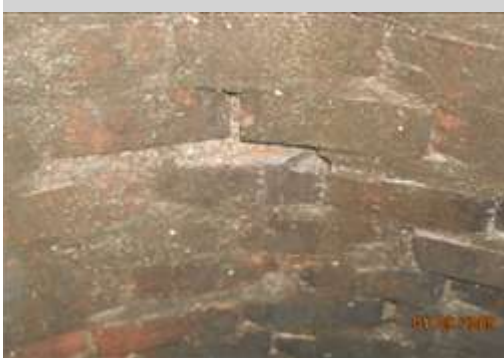
Defect 5

Condition: ☐ Sound ☒ **Cracked** ☐ Root Intrusion ☐ Loose Brick ☐ Deteriorated

Infiltration: ☐ None ☒ **Joint** ☐ Cracks ☐ Mortar ☐ Roots ☐ Wall

infiltration and CRACKED CORBEL MORTAR

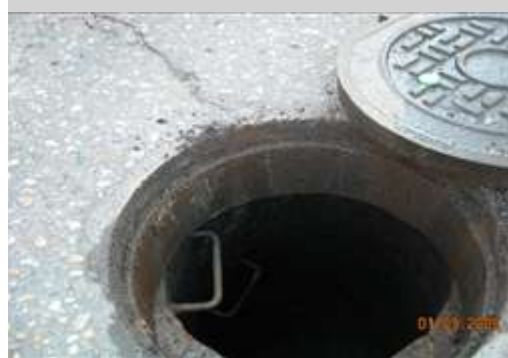
Defect 4

Subject To Ponding: **Sheeting**

INFLOW EVIDENCE FROM SHEETING

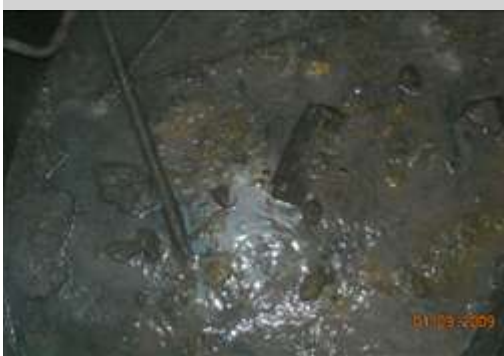
Defect 3

Condition: ☐ Sound ☐ Cracked ☐ Root Intrusion ☐ Deteriorated ☐ Leaks ☒ **Debris**

DEBRIS IN TERMINAL CHANNEL

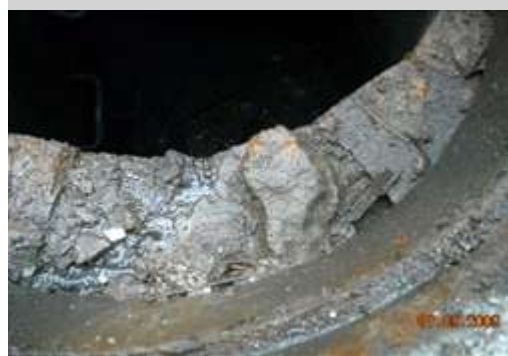
Defect 2

Frame Offset: **6** (in.) Condition: ☐ Sound ☐ Cracked ☒ **Leaks**

FRAME OFFSET

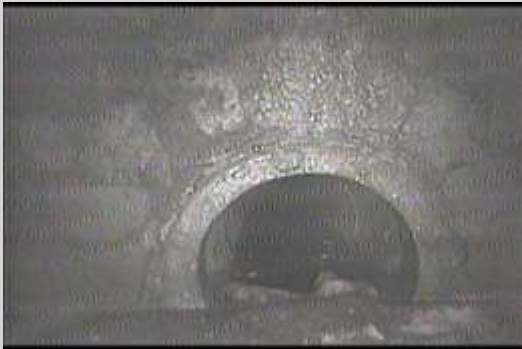
12 O'Clock Outflow

8 in. Circular Gravity Sewer
Pipe Out @ 12 O'Clock

Pipe Height: **8.4** (in.) Rod and Bar (Angled)
Pipe Material: **Clay** ☐ Pipe Lined
Invert Depth: **7.33** (ft.) Flow Characteristics: **Slow**
Deposits: ☐ None ☐ Mud ☒ Sludge ☒ Debris ☒ Grease
Silt Depth: **3** (in.) Deposits Extent: **Medium**
Infiltration: **Evidence** Pipe Seal Cond: **Sound**

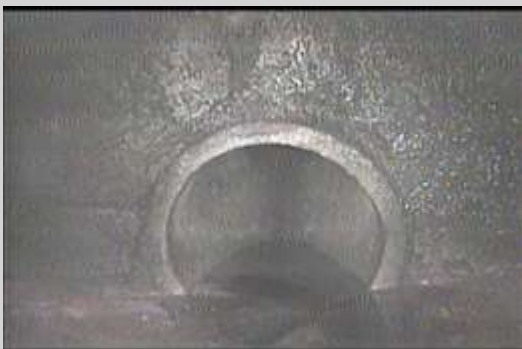
5 O'Clock Inflow

6 in. Circular Gravity Sewer
Pipe In @ 5 O'Clock

Pipe Height: **6** (in.) Rod and Bar (Angled)
Pipe Material: **Clay** ☐ Pipe Lined
Invert Depth: **7.19** (ft.) Flow Characteristics: **Slow**
Deposits: ☒ None ☐ Mud ☐ Sludge ☐ Debris ☐ Grease
Silt Depth: **0** (in.) Deposits Extent:
Infiltration: **None** Pipe Seal Cond: **Sound**
